# Manhole Inspection Summary

Manhole # S27A\_\_006MH

**Location** Address: **857 HARLEM AVE**

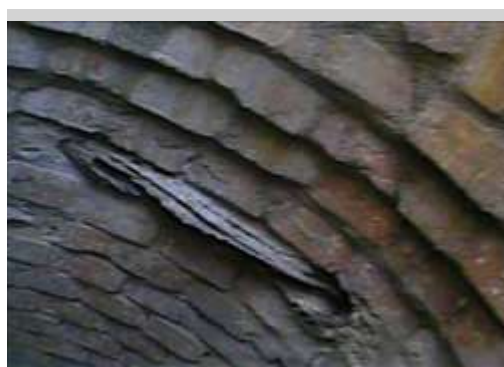
Defect 1

Condition: ☐ Sound ☐ Cracked ☐ Root Intrusion ☐ Loose Brick ☒ **Deteriorated**

CORRODED CORBEL WALL

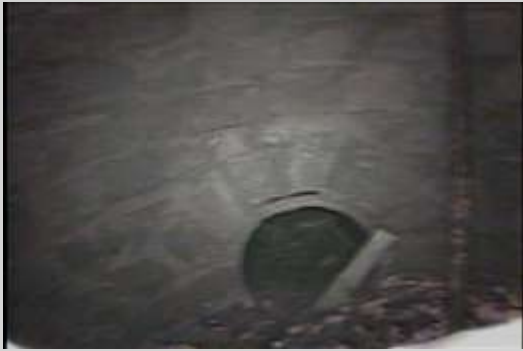
12 O'Clock Outflow

8 in. Circular Gravity Sewer  
Pipe Out @ 12 O'Clock

Deposits: ☐ None ☐ Mud ☐ Sludge ☒ **Debris** ☐ Grease

Silt Depth: **3** (in.) Deposits Extent: **Medium**
